Proposed Residential Development,
Dalguise House, Monkstown Road,
Co. Dublin

Quality Audit

Document Ref:	P22-148-UQA-GEN-RP-001
----------------------	-------------------------------

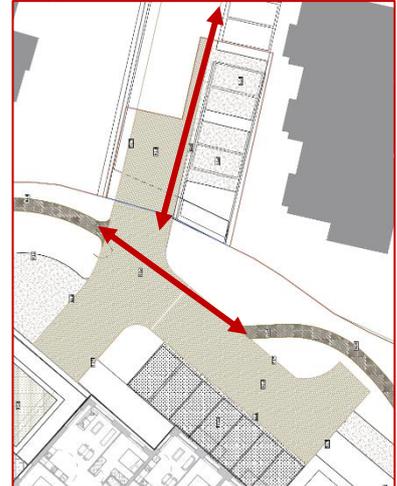
Location: Shared Carriageway at Purbeck

Summary: Lengthy pedestrian routes through busy area of shared carriageway.

It is unclear where the existing footpath on Purbeck will tie-in with the internal development footpaths. It appears that the existing footpath will connect into a shared carriageway, at a location where 80% of vehicular traffic entering/exiting the development will also be using the carriageway.

In addition, proposed loose bark surfaced paths connect with this shared carriageway in the vicinity of the proposed crèche, and in order to continue along the path of pedestrians will be required to travel within the shared carriageway over a longer than necessary distance.

Lengthy pedestrian routes through a relatively busy section of carriageway would lead to an increased risk of vehicle/pedestrian collisions.

The existing footpath provision along Purbeck should be extended into the proposed development, with appropriate crossings on likely crossing desire lines. The layout of the loose bark surfaced paths should be amended in order to provide a crossing which is as short as practicable.

On the approaches to the interface with the carriageway, a section of the loose bark surfaced paths should be paved and tactile paving provided to warn pedestrians of the upcoming crossing.

Issue	Situation	Action/Adjustment	Priority	Cost
3.5.1	Lengthy pedestrian routes through busy area of shared carriageway, where the existing footpath on Purbeck will tie-in with the internal development footpaths. In addition, proposed loose bark surfaced paths connect with this shared carriageway in the vicinity of the proposed crèche, and in order to continue along the path of pedestrians will be required to travel within the shared carriageway over a longer than necessary distance.	The existing footpath provision along Purbeck should be extended into the proposed development, with appropriate crossings on likely crossing desire lines. The layout of the loose bark surfaced paths should be amended in order to provide a crossing which is as short as practicable.	1	B

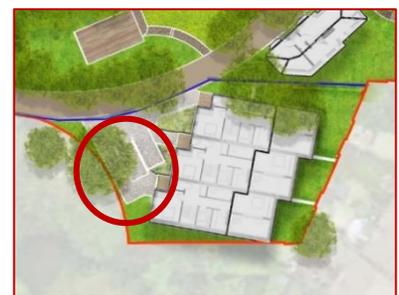
Location: North West Houses

Summary: Offset parking spaces at the North West Houses may lead to unsafe reversing manoeuvres onto the carriageway.

The design indicates parking spaces at the North West Houses being offset from the access road.

Drivers exiting these parking spaces may be required to reverse over a relatively long distance when entering the access road, with limited visibility towards approaching traffic, including pedestrians or cyclists, on the access road. This may increase the risk of vehicle/pedestrian and side-on collisions or rear-end shunts.

The parking spaces should be relocated closer to the access road carriageway with sufficient visibility towards approaching vehicles, bicycles and/or pedestrians on the Avenue.

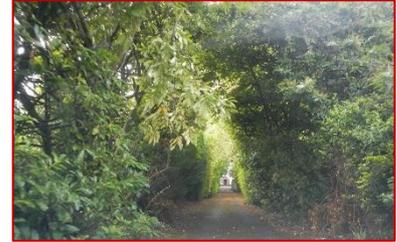
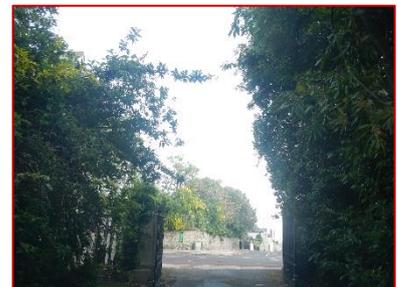
Location: Existing Dalguise House Access Avenue

Summary: Narrow shared access road may not be able to accommodate opposing traffic and narrow gateway could increase the risk for pedestrians/cyclists.

It is proposed to retain the existing Dalguise House Access Avenue as one of the accesses to the proposed development. The Avenue is not indicated as being modified and is to be used by two-way vehicular traffic and by pedestrians and cyclists.

The existing avenue consists of a single lane without footpaths, with a narrow gateway onto Monkstown Road. The avenue is not wide enough to accommodate vehicles passing in opposite directions.

The narrow carriageway and the absence of dedicated facilities for pedestrians/cyclists may increase the risk of collisions, particularly during poor weather conditions or during the hours of darkness when visibility could be limited by the absence of lighting along the route.

The narrow gateway could lead to vehicles wishing to turn into the development having to wait on Monkstown Road due to an exiting vehicle waiting for a gap in Monkstown Road traffic before exiting. In addition, the narrow gateway could result in insufficient inter-visibility between drivers of entering/exiting vehicles and pedestrians/cyclists.

The avenue should be amended so that it can safely accommodate two-way traffic (e.g. a widened carriageway or the provision of appropriately located passing bays)

A footpath and public lighting should be provided along the avenue, and the existing trees/vegetation cut back to ensure adequate visibility and so as not to impede the public lighting.

The existing gateway either should be widened to safely accommodate vehicles, pedestrians & cyclists, or a layby should be provided immediately inside the gate with a pedestrian gate to facilitate pedestrian and cyclist entry/exit without the need to interface with vehicles entering/exiting the narrow gateway.

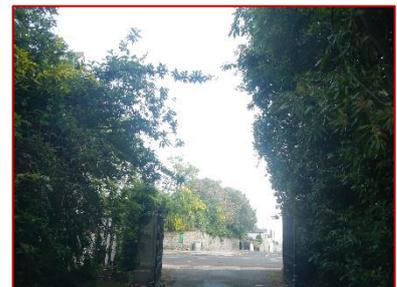
Location: Dalguise House Access Avenue

Summary: Narrow access may result in delays for Emergency Vehicles.

Emergency Vehicle may seek to access the development along the Dalguise House Access Avenue. The existing avenue and entrance gateway is narrow, and there is a consequent risk of delays for Emergency Vehicle access, in particular at the narrow gates.

Delays in emergency services response times may increase injury severity.

Safe access for emergency vehicles should be available without unnecessary delays.

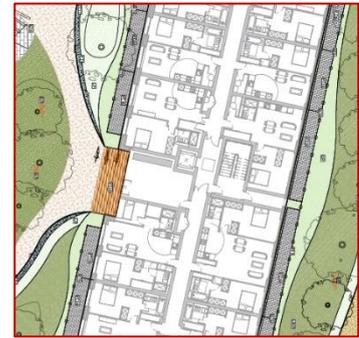
Location: Block F & G

Summary: Items blocking building entrances may constitute a hazard.

Cycle parking has been indicated at the steps into Blocks F & G. The proposed location of the bicycle parking may result in difficulties for bike users in safely accessing the parking provisions.

In addition, there is a concern that the bicycle parking may impede emergency egress from the building entrance, resulting in an increased risk of injury in emergency situations.

The bicycle parking should be relocated away from the immediate entry/exit & steps into the buildings.

3.5.5	Cycle parking blocking building entrances may constitute a hazard	The bicycle parking should be relocated away from the immediate entry/exit & steps into the buildings.	1	A

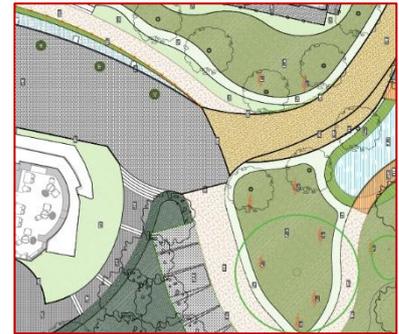
Location: Junction immediately north of Block H

Summary: Lack of junction control and insufficient visibility at the internal junction may result in unsafe exiting manoeuvres

The internal road which will provide access to Blocks I (East) and I (West) intersects with the main access road at a junction to the north of Block H.

Visibility for drivers exiting from the minor arm at this junction may be impeded by the proposed position of the planting/trees at the junction. Insufficient visibility could result in unsafe exiting manoeuvres from the side road leading to side-on collisions with through traffic on the main access road.

The junction priority should be clearly signed/marked and landscaping/planting/trees should be positioned where they will not impede visibility for drivers at the junction.

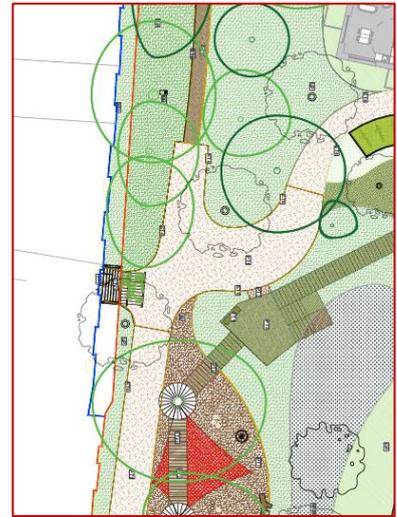
Location: Intersection of Paved Path with Paved Shared Road

Summary: Drivers may enter path from shared road.

Measures should be put in place to prevent vehicles continuing from the shared paved road onto the paved path.

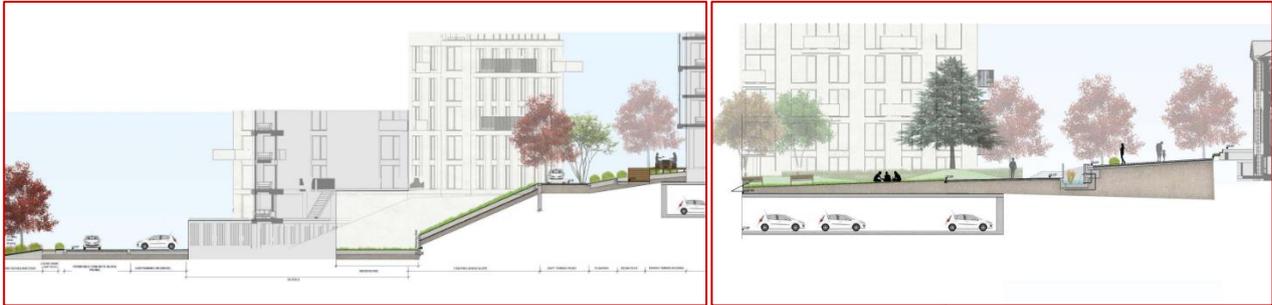
Location: General problem

Summary: Lack of edge protection may result in falls from height.

At a number of locations throughout the development level differences are indicated, some adjacent to shared roads/footpaths. It is unclear from the information provided if edge protection is proposed at these locations. A lack of edge protection may result in pedestrians or cyclists falling from height, resulting in personal injury.

During the design development edge protection should be provided at all locations where there is a risk of falls from height.

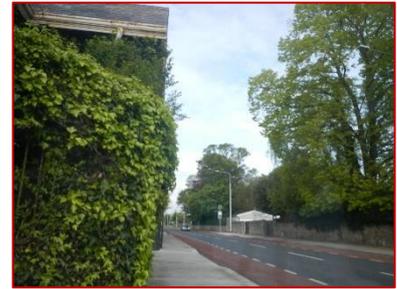
The existing visibility at the Dalguise House Access Avenue gateway on Monkstown Road may result in an exiting vehicle encroaching into the carriageway/cycle lane on Monkstown Road before sufficient visibility is available towards approaching vehicles.

This could result in cyclist avoidance measures (swerving) which may not be anticipated by following drivers resulting in vehicular/cyclist collisions.

Visibility for drivers exiting the Dalguise House Access Avenue should be available without need for the exiting vehicle to encroach into the carriageway/cycle lane.

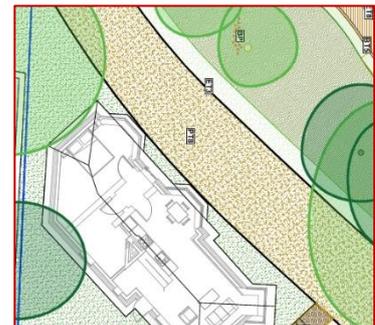
Summary: Lateral clearance to Brick Gate Lodge.

It is proposed to retain the Brick Gate Lodge, with the internal road indicated in close proximity to the lodge building. It is unclear if there is sufficient lateral clearance between the building and the proposed carriageway, insufficient setback could result in the building being struck by passing vehicles resulting in material damage.

Adequate lateral clearance should be provided between the edge of the carriageway and the Brick Gate Lodge building.

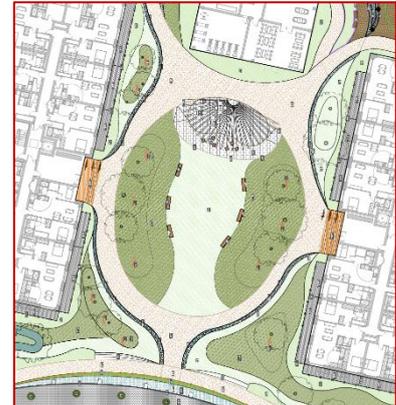
Summary: Rills may represent a hazard for visually impaired.

Rills of 150 mm depth height are proposed alongside the paths. The proposed rills may represent a height hazard for visually-impaired or inattentive pedestrians. Insufficient warning of the height hazard may result in the visually-impaired being unable to detect the hazard.

Provide warning paving to advise visually-impaired or inattentive pedestrians of the hazard.

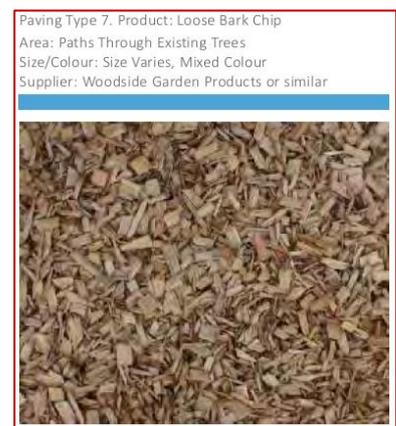
Location: General Problem – Loose Bark Surfaced Paths

Summary: Unbound road surface may represent slip and trip hazard

It is proposed to provide unbound “Loose Bark Chip” path material for some of the internal footpaths. The unbound material may deteriorate over time, creating unstable or uneven ground, leading to slips, trips or falls.

It is also unclear if unbound surfacing is proposed on the steps along the unbound paths. Loose material on the steps may exacerbate the risk of slips, trips or falls.

During the design development the proposed path surface and step surfaces should be designed so as not to present a slip or trip hazard.

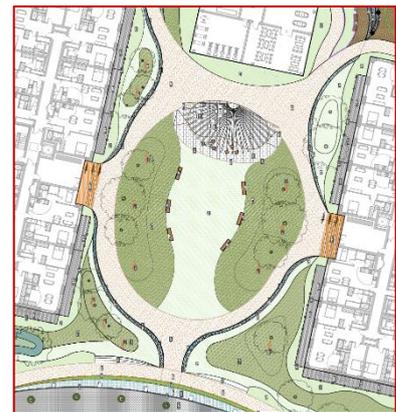
Summary: "Ha-ha" may present a height hazard.

It is proposed to provide a 'Ha-ha' feature, with associated water basin and water shoots, within the Central Plaza. The Ha-ha may present a height hazard for visually impaired or inattentive pedestrians on upper level, leading to possible falls from height.

Edge protection should be provided at the Ha-ha.

3.5.17	The 'Ha-ha' feature may present a height hazard for visually impaired or inattentive pedestrians on upper level, leading to possible falls from height.	Edge protection should be provided at the Ha-ha	1	A

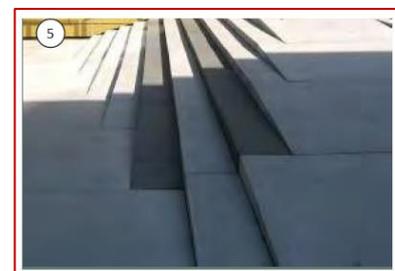
Location: Central Approach

Summary: Stramps may present a height-hazard for the visually-impaired.

It is proposed to provide stramps (combined steps & ramps) within the Central Approach area of the proposed development. It is unclear from the information provided whether it is intended to provide hazard warning tactile paving at the proposed stramps. The proposed stramps could present a hazard for the visually-impaired should be the insufficiently aware of the height-hazard leading to possible trips or falls.

Hazard tactile paving should be provided at the proposed stramps.

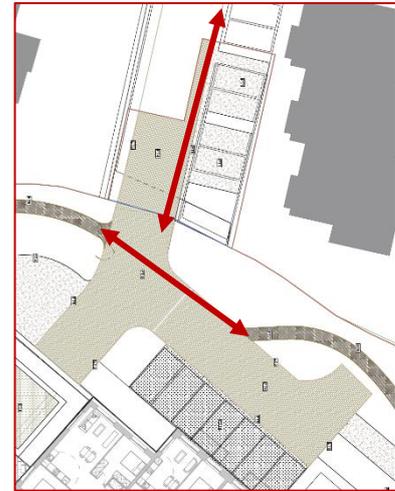
A shared carriageway is proposed at the Purbeck entrance, a location where 80% of vehicular traffic entering/exiting the development will also be using the carriageway.

The existing footpath along Purbeck terminates, with vulnerable road users expected to travel within the shared carriageway. The proposed loose bark surfaced paths connect with this shared carriageway in the vicinity of the proposed crèche, and in order to continue along the path of pedestrians will be required to travel within the shared carriageway over a longer than necessary distance.

The proposed arrangements at this location are likely to create difficulties for pedestrians, and in particular visually-impaired & mobility-impaired non-motorised road users, travelling along and through this area.

4.3.1	The existing footpath along Purbeck terminates, with vulnerable road users expected to travel within the shared carriageway. The proposed loose bark surfaced paths connect with this shared carriageway in the vicinity of the proposed crèche, and in order to continue along the path of pedestrians will be required to travel within the shared carriageway over a longer than necessary distance. The proposed arrangements at this location are likely to create difficulties for pedestrians, and in particular visually-impaired & mobility-paired non-motorised road users, travelling along and through this area	Segregated footpaths with defined crossings of the carriageway should be provided at this location.	1	A
