Proposed Residential
Development, Dalguise House,
Monkstown Road, Co. Dublin

Quality Audit Stage 1

Document Ref:	P23-074-RP-QA-3_01
----------------------	---------------------------

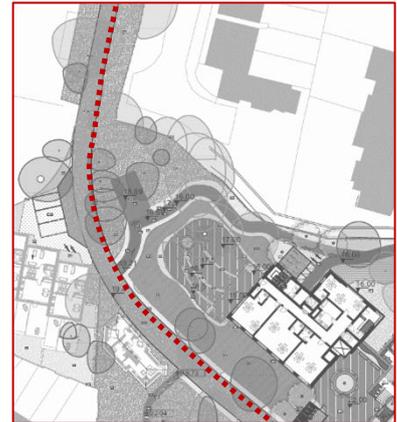
The extensive shared area along the Avenue does not include a Safe Zone for visually-impaired pedestrians. In addition, it is unclear if any warning is provided to visually-impaired pedestrians of the non-accessible routes within the development (e.g. pedestrian routes that have a loose surface or which include steps).

A “Safe Zone” should be provided within all shared paths to enable visually-impaired pedestrians to independently navigate the proposed road layout.

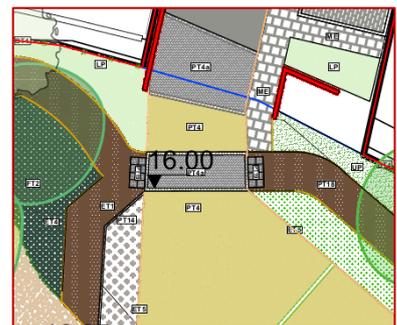
A zebra crossing arrangement has been indicated at the pedestrian crossing of Purbeck. It is unclear if it is intended that this will, in fact, be a zebra crossing. If so, Belisha beacons would be required noted to confirm pedestrian/cyclist priority at this crossing.

If it isn't at zebra crossing, then this route may not be accessible to visually impaired pedestrians entering/exiting the development along Purbeck, confining them to the shared route along the Avenue, where there is no Safe Zone.

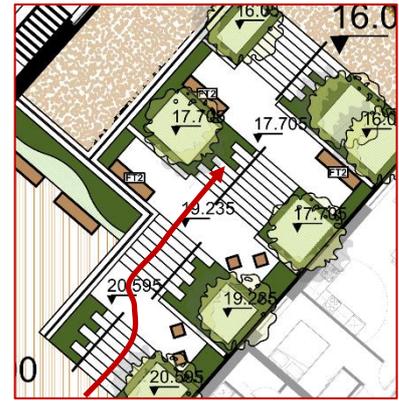
The arrangement of the handrails indicated along the steps may lead to visually impaired pedestrians inadvertently entering the grassed side of the steps where there is an increased risk of slips, trips and falls, particularly during wet/icy weather conditions.

Measures should be provided to guide visually impaired pedestrians through the series of steps.

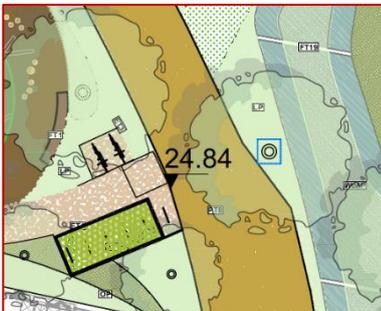
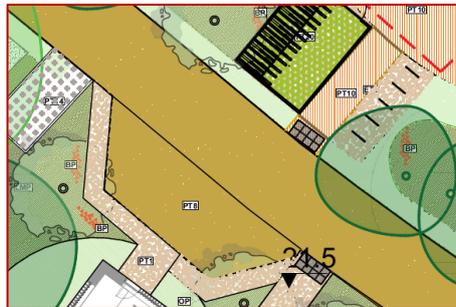
At a number of locations the shared NMU path joins the shared carriageway, however, at some of these locations no tactile paving is provided. For example, in front of Dalguise House the shared NMU path joins the shared carriageway at two locations, however no tactile paving has been indicated to warn visually impaired pedestrians that they are about to enter an area shared with vehicles at the western end of the of the ‘Ha-Ha’ water feature.

The absence of tactile paving at these locations could lead to visually impaired pedestrians being unaware that they have entered a space shared with vehicles.

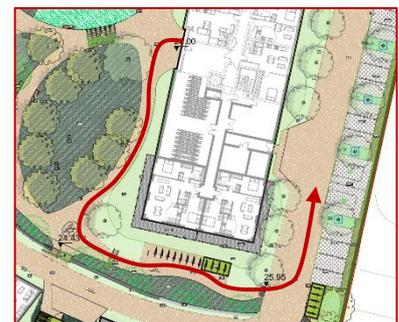
Car parking spaces associated with Block J are located at surface level to the rear of the building. However, no mobility impaired parking spaces have been provided at this location adjacent to Block J. The absence of a mobility impaired parking space may lead to mobility impaired vehicle occupants parking at an alternative accessible parking space and travelling a long distance between their vehicle and the building entrance.

In addition, the mobility parking spaces associated with Block H are located to the rear of the building entrance and would require mobility impaired vehicle occupants a long distance between their vehicle and the building entrance.

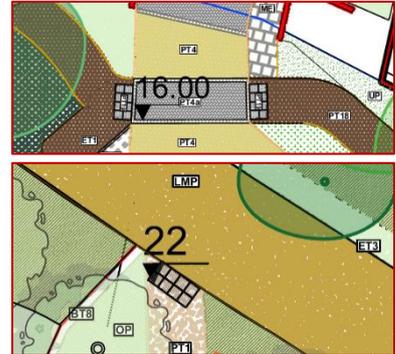
At a number of locations where the proposed crossings are in-line with the footway it is proposed to provide 800mm deep tactile paving as opposed to 1200mm. Incorrect tactile paving provision could increase the risk of visually impaired pedestrians stepping over the tactile arrangement, and inadvertently entering the carriageway where there is an increased risk of being struck by a vehicle.

Tactile paving should be 1200mm in depth at in-line crossings.

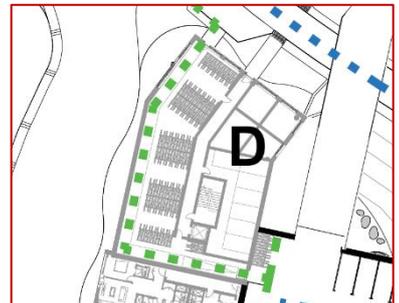
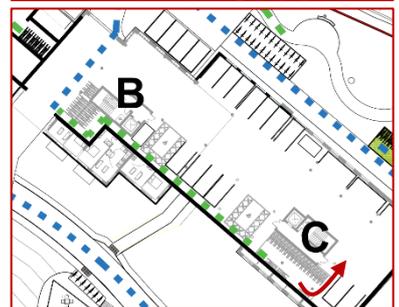
The width of the proposed access routes to long-stay bicycle parking areas within the basement car parks of Block D and Block B & C has not been indicated in the drawings provided. It is therefore unclear if an adequate width would be provided for cyclists to comfortably access/egress the parking areas. Furthermore, the proposed cycle route within the basement car park of Block B & C would require cyclists to travel to the rear of car parking spaces where the route may become obstructed by a parked vehicle. A narrow access route may result in there being insufficient space for cyclists to pass one another.

Cycle parking access routes should be at least 1.5m, preferably 2.0m, wide between walls/fences. A reduced width of 1.2m is acceptable over short distances, i.e. less than 10m

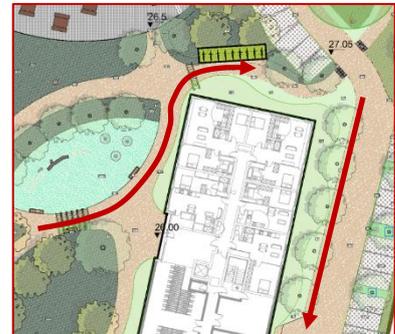
Insufficient clearance to the tree canopies will present a hazard to cyclists, or lead to sudden avoidance manoeuvres by cyclists.

A vertical clearance of 2.5m should be provided on all cyclist routes within the development.

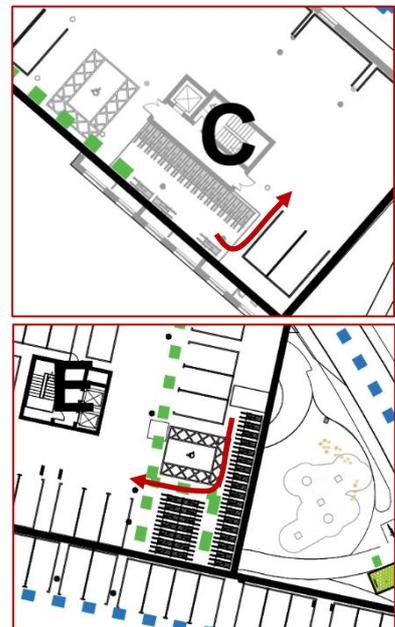
Long-stay bicycle parking areas have been indicated in adjacent to car parking spaces within the basement car parks associated with residential Block C and Block E.

Sufficient space between the bicycle parking areas and car parking spaces should be provided such that cyclists can comfortably enter/exit these areas.

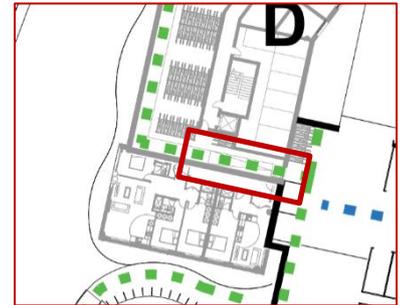
A ramp is indicated within the underground car park providing a link to an area of long-stay bicycle parking. The gradient of this ramp has not been indicated on the drawing provided. If the gradient of the ramp is steeper than 1:20 there is a risk that cyclists may experience difficulties when using the ramp leading to the potential for them to roll backwards or be unable to wheel their bicycle up the ramp.

Access to the long-stay bicycle parking at this location should be facilitated by ramped access with appropriate gradients or elevator access.

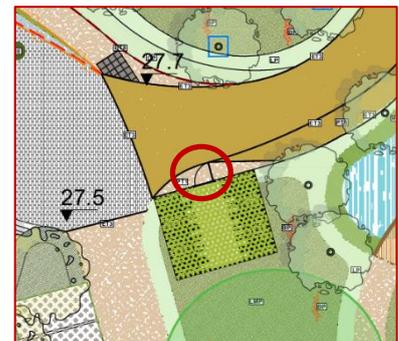
Manually operated doors may present difficulties for cyclists accessing/egressing the underground parking area.

Doors used by cyclists should be operated electronically by automatic detection or with the push button 3m from the door.

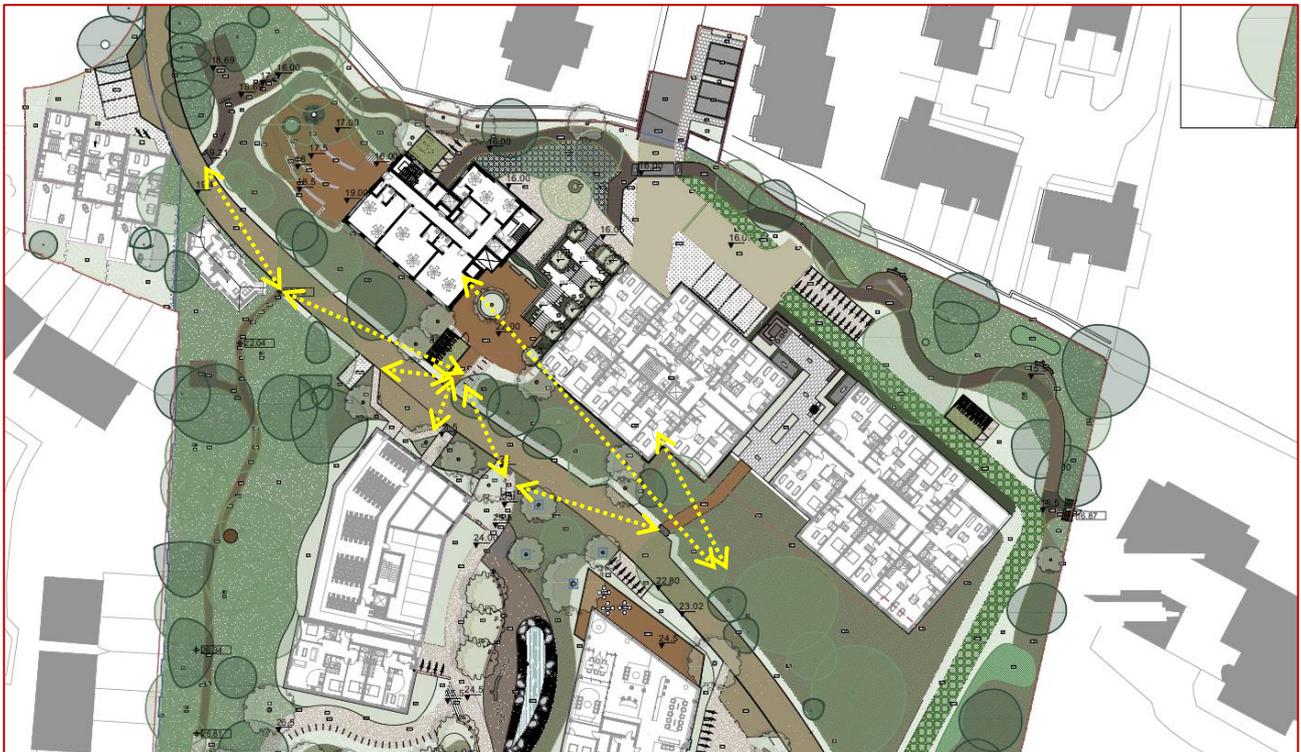
This would be a particular issue for visually-impaired or partially-sighted pedestrians.

The likely pedestrian crossing desire lines should be assessed and, where necessary, the proposed paths should be amended to better serve the identified crossing desire lines and to reduce the exposure of pedestrians to vehicles and cyclists.

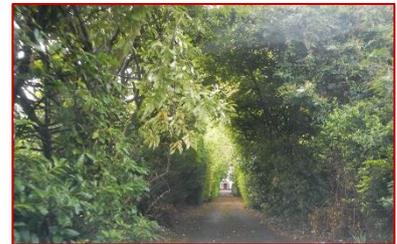
The narrow carriageway, to be shared with cyclists, pedestrians & vehicles, and the absence of a "Safe Zone" would result in difficulties for visually-impaired & partially-sighted pedestrians safely & independently navigating this route.

A safe route for the visually-impaired should be provided to/from the Monkstown Road and the development (e.g. a "Safe Zone" or a footpath provided along the Avenue).

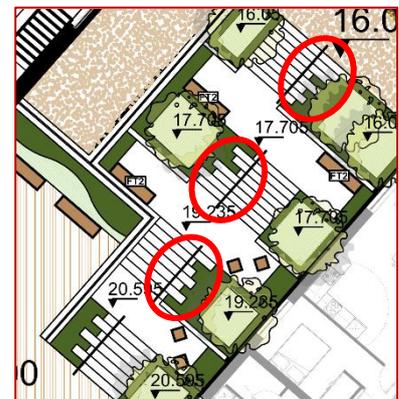
It is unclear how pedestrians, in particular the visually-impaired, would be advised that they should not walk on the grassed side of the steps. A lack of measures to warn/deter pedestrians from using the grassed side, could increase the risk of slips, trips and falls in particular during wet or icy weather.

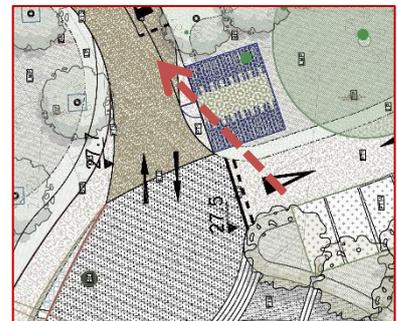
Visibility for drivers exiting from the minor arm at this junction may be impeded by the proposed bicycle shelter at the junction. Insufficient visibility could result in unsafe exiting manoeuvres from the side road leading to side-on collisions with through traffic on the main access road.

The bicycle shelter should be re-positioned to where it will not impede visibility for drivers at the junction.

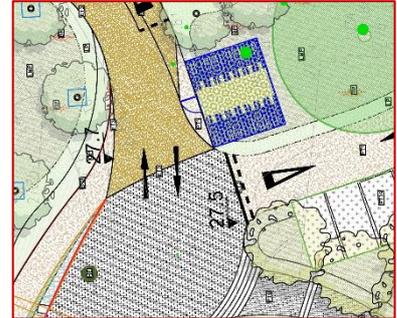
The door on the cycle shelter is indicated as opening towards the Avenue, and close to the possible path of vehicles. This could lead to cyclists opening the door ahead of oncoming vehicle or stepping out on the shared path in front of an oncoming vehicle.

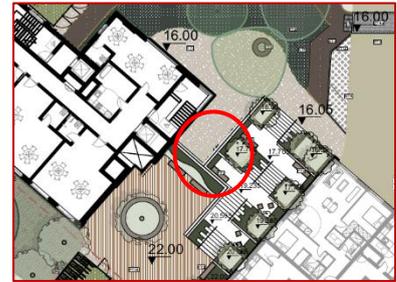
At a number of locations throughout the development level differences are indicated. It is unclear from the information provided if edge protection is proposed at these locations. A lack of edge protection may result in pedestrians falling from height, resulting in personal injury.

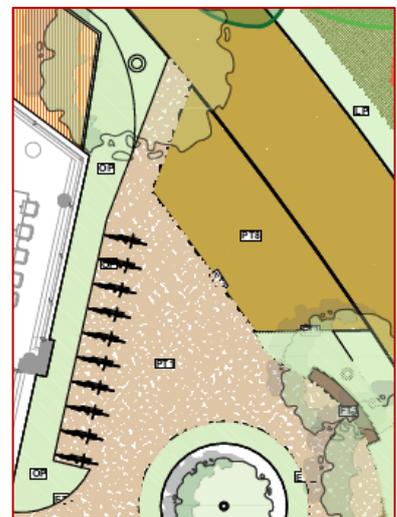
At a number of location where the interface between the paths and shared road is wide, drivers intentionally or inadvertently enter the path, for example to park, resulting in an increased risk of vehicular/NMU collisions or the creation of obstacles for NMU's, in particular the visually-impaired or mobility-impaired.

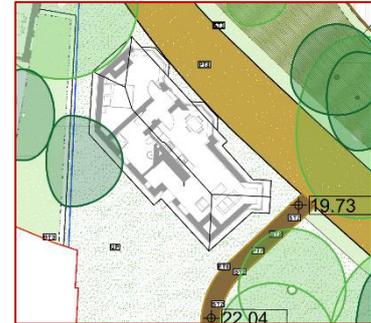
It is proposed to retain the Brick Gate Lodge, with the internal road indicated in close proximity to the lodge building. It is unclear if there is sufficient lateral clearance between the building and the proposed carriageway, insufficient setback could result in the building being struck by passing vehicles resulting in material damage.

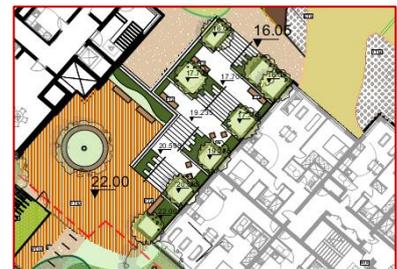
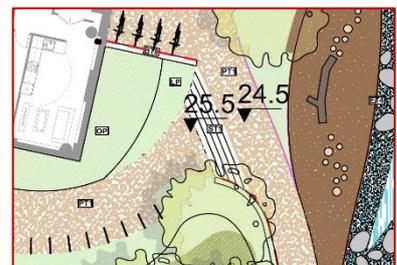
Summary: Hazard tactile paving has not been indicated at the top and bottom of steps within the development.

Steps have been indicated throughout the development, for example in between apartment blocks A and B. Hazard tactile paving has not been indicated at the top or bottom of these steps. This could lead to visually impaired pedestrians being insufficiently aware of the vertical hazard ahead resulting in them inadvertently entering the steps resulting in trips, falls and serious injury.

Hazard tactile paving should be provided at the top and bottom of steps.

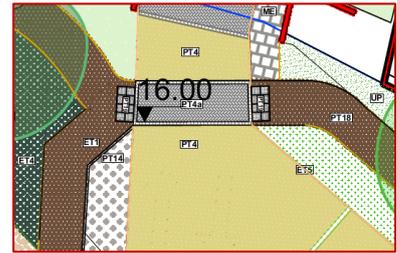
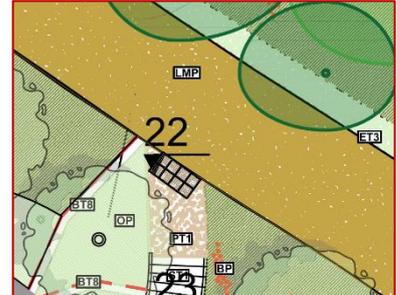
Where tactile paving is less than 1.2m in depth from the kerb line at in-line crossings, there is a risk of visually impaired pedestrians stepping over the tactile paving and inadvertently entering the carriageway where they may be struck by a vehicle or cyclist.

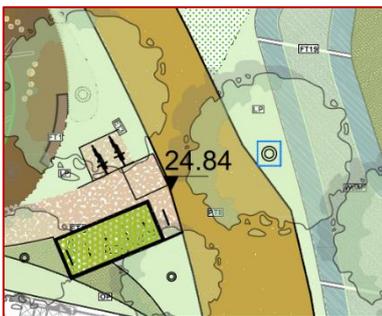
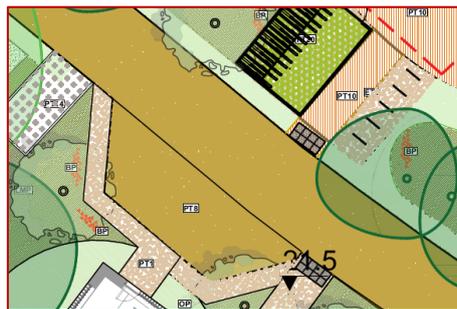
An absence of tactile paving at these locations could lead to visually-impaired pedestrians unknowingly entering the carriageway where there is an increased risk of being struck by a vehicle.
