Proposed Residential
Development, Dalguise House,
Monkstown Road, Co. Dublin

Quality Audit Stage 1

Document Ref:	P23-074-RP-QA-3_01
----------------------	---------------------------

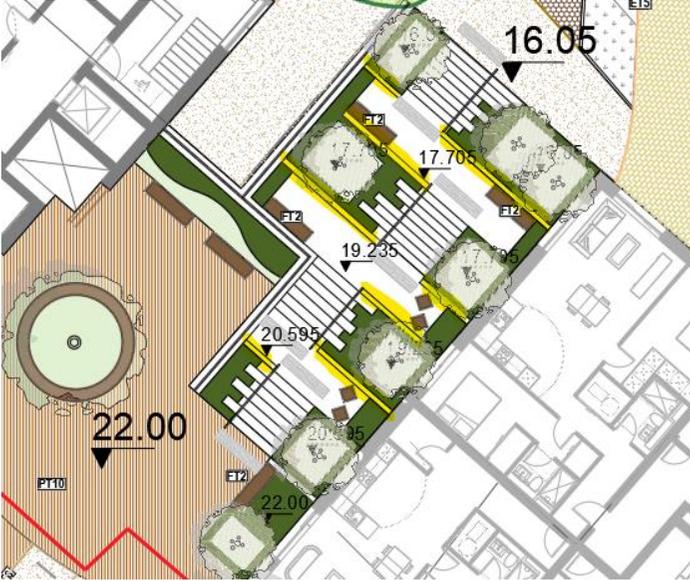
Item No.	Summary of Issue	Individual Audit References				Design Team Response/Action
		Access Audit	Walking Audit	Cycle Audit	Road Safety Audit	
4	Grassed Steps	I.2.4			V.3.6	<p>Please refer to Road Safety Audit Feedback Form in Appendix V.</p> <p>A low wall would separate the grassed area of steps, these areas will be inaccessible and only provide visual interest.</p>

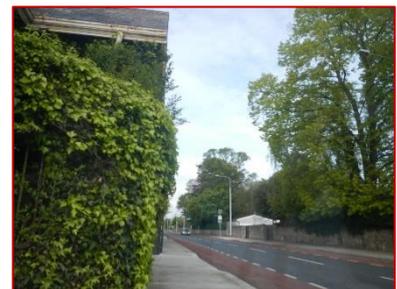
The existing visibility at the Dalguise House Access Avenue gateway on Monkstown Road may result in an exiting vehicle encroaching into the carriageway/cycle lane on Monkstown Road before sufficient visibility is available towards approaching vehicles.

This could result in cyclist avoidance measures (swerving) which may not be anticipated by following drivers resulting in vehicular/cyclist collisions.

Visibility for drivers exiting the Dalguise House Access Avenue should be available without need for the exiting vehicle to encroach into the carriageway/cycle lane.
